Home Inspection Report

1234 New Street
Better City, North Carolina 27215

Date of Inspection: Saturday, February 28, 2015

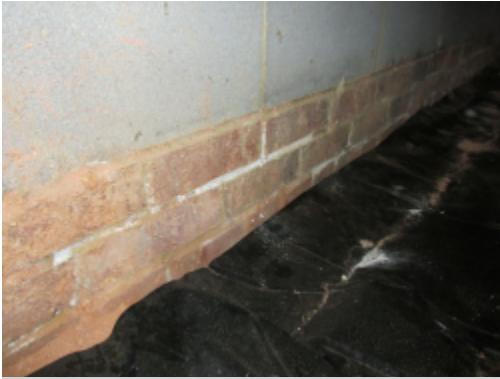
(A1 - 1.1) Main House

Efflorescence (salt stains) was noted on the foundation walls. The stains indicate that the foundation was been cyclically wet and dry. Water penetration into the foundation area can result in structural damage and undesirable environmental conditions. Water in the foundation area indicates an absent or damaged waterproofing and foundation drain systems. Repairs are needed to prevent water penetration. A general contractor should be consulted for further evaluation to determine the source of the moisture and to make necessary repairs.

Efflorescence (salt stains) was noted on the foundation walls. The stains indicate that the foundation was been cyclically wet and dry. Water penetration into the foundation area can result in structural damage and undesirable environmental conditions. Water in the foundation area indicates an absent or damaged waterproofing and foundation drain systems. Repairs are needed to prevent water penetration. A general contractor should be consulted for further evaluation to determine the source of the moisture and to make necessary repairs. Refer to the exterior section of the report concerning the lot grading.

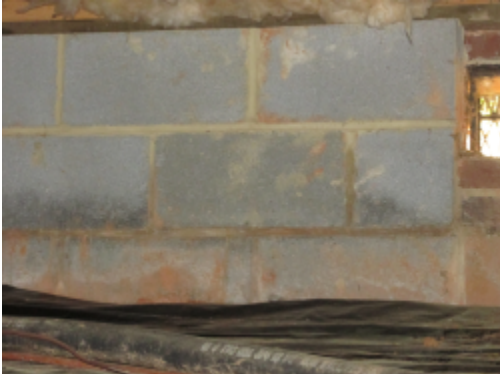
(A1 - 1.2) Main House

Stains and water lines indicate a history of standing water in the crawl space around the perimeter of the foundation and under the porches. Direct water penetration damages the foundation, the wood structure, and creates an undesirable environment in the crawl space areas that encourages insect, fungal growth such as mold/mildew. Repairs are needed to prevent water penetration. Water in the crawl space indicates an absent or damaged waterproofing and foundation drain system. Repairs are needed to prevent water penetration. A general contractor should be consulted for further evaluation to determine the source of the moisture and to make necessary repairs.

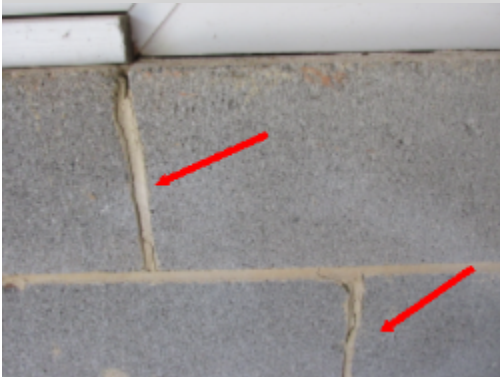
(A1 - 2.1) Garage

Closed cracks were noted in the foundation of the garage at locations where the foundation steps related to elevation change. Cracks in the foundation indicate a deficiency in the foundation, footing, or supporting soil that can change and worsen if it progresses over the life of the home. An engineer should be consulted to determine the significance /cause of the cracks and outline any necessary repairs.

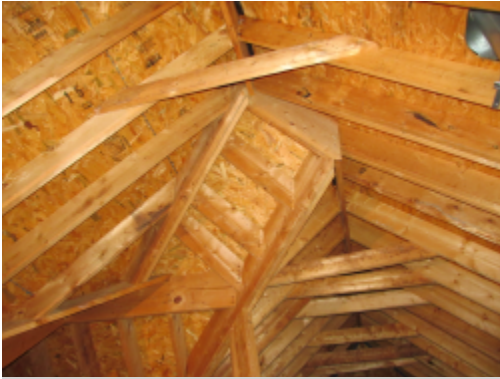
(A6 - 1.1) Main House

From the attic, it was noted that the Valley/Hip rafter located between the main home and first floor room was not posted for end support. End post supports are typically installed to supplement nailed joints and ensure the stability of the roof system. An engineer should be consulted for further evaluation to determine the significance and cause of the concern and outline necessary repairs to ensure the stability of the structure.

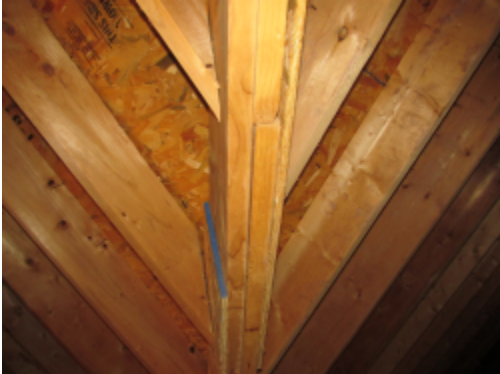
(A6 - 1.2) Main House

From the attic, it was noted that the valley rafter located over the main living room was constructed of multiple members and was not posted for support. Post supports are typically installed to supplement nailed joints and ensure the stability of the roof system. An engineer should be consulted for further evaluation to determine the significance and cause of the concern and outline necessary repairs to ensure the stability of the structure.

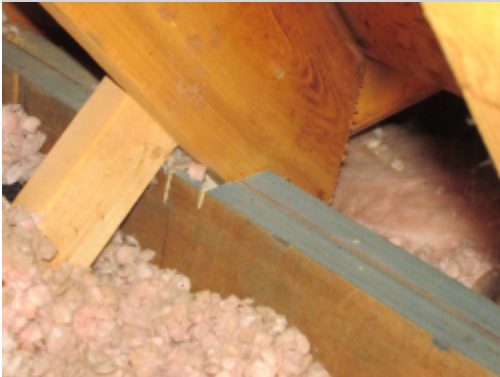
(A6 - 1.3) Main House

The LVL girder located under the main rafters on the front side of the home has been notched for rafter installation. Engineered lumber beams have specific installation specifications that rarely allow notching. If a notch is beyond what would be typically expected and could result in cracking or failure of the beam. A girder is a main structural component that provides support of the framing structure and transfers loads to the foundation. An engineer should be consulted for further evaluation to determine the significance of the concern and outline necessary repairs to ensure the stability of the structure.

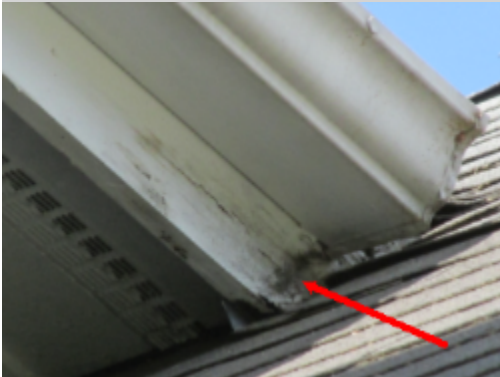
(B1 - 1.1) Main House Front

The exterior boxing of the home need repairs and painting to prevent further damage and water penetration. The following items were noted during the inspection all areas should be evaluated as a repair plan is prepared:

1. Peeling paint, swollen edges behind the gutter trays;
2. Boxing and trim areas were found to have area of decay at roof line intersections

A licensed general contractor should be consulted for a complete evaluation of the trim and boxing to determine the scope of the damage and make necessary repairs.

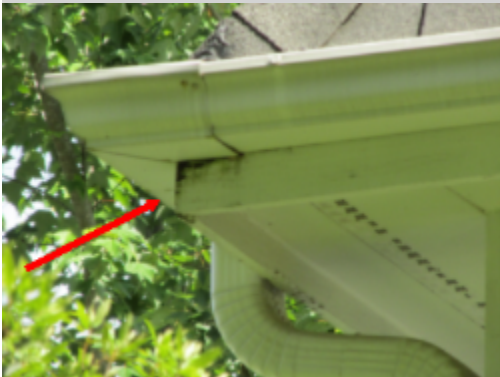
(B1 - 1.2) Main House Front

Additional Photograph: This a photograph of decayed boxing at the left front corner of the main home. All corner trims areas were noted to have some level of decay.

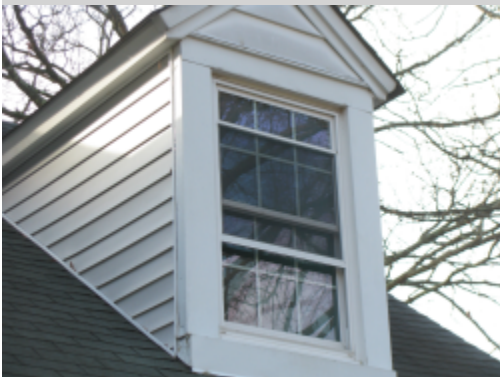
(B1 - 1.3) Main House Front

The trim cladding along the roof rake / eave was not formed to provide a lip to support the shingles and prevent water from traveling behind the trim. A siding installation company or general contractor should be consulted to evaluate and repair the trim to ensure the integrity of the cladding system.

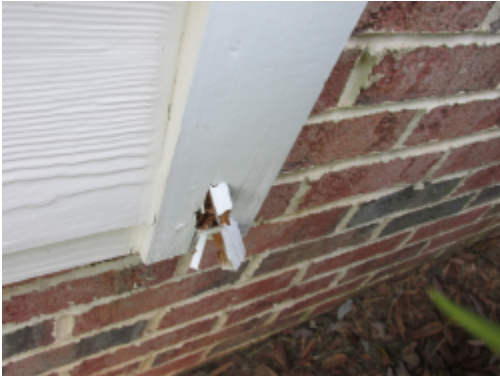
(B1 - 2.1) Main House Rear and Sides

The exterior trim of the home need repairs and painting to prevent further damage and water penetration. The following items were noted during the inspection all areas should be evaluated as a repair plan is prepared:

1. Corner trim moldings have visible areas decay.
2. Vertical wood trim boards at corner and brick intersections have visible areas of decay.

A licensed general contractor should be consulted for a complete evaluation of the exterior trim to determine the scope of the damage and make necessary repairs.

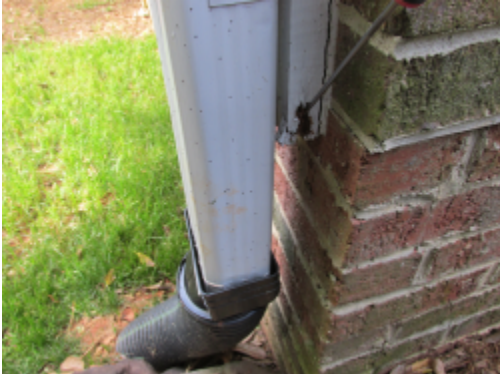
(B1 - 2.2) Main House Rear and Sides

Additional Photograph: This a photograph of a decayed vertical trim molding behind the back left gutter.

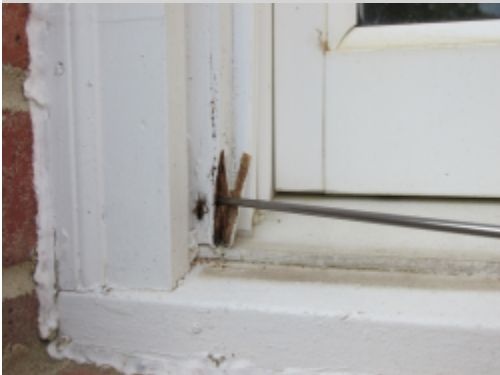
(B2 - 1.1) All Windows

The all windows have soft and decayed wood in the sill, trim, sash areas. Decay in the windows can result in leaking and water penetration and should be repaired as soon as possible. All windows should be inspected for similar damage as repairs are made. A licensed general contractor should be consulted to evaluate the extent of the damage and make necessary repairs.

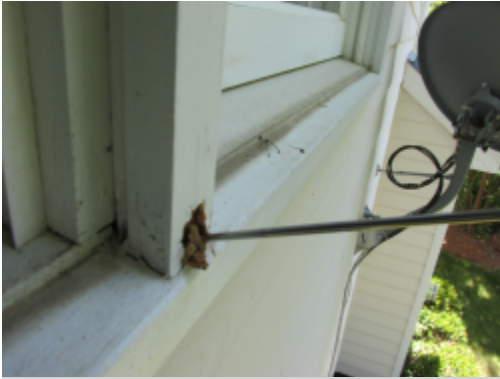
(B2 - 1.2) All Windows

Additional Photograph: This a photograph of the living room window, the trim between the windows is decayed.

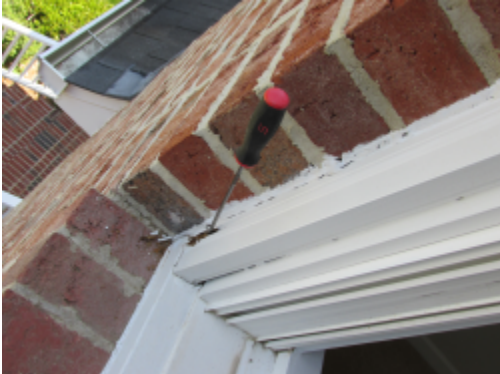
(B2 - 1.3) All Windows

Additional Photograph: This a photograph of a second floor window, decay was noted in all accessible windows.

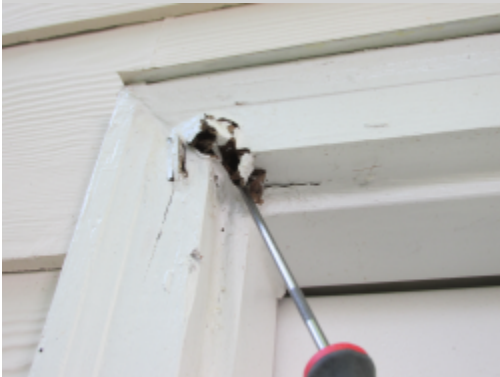
(B2 - 2.1) Door

The door has extensive soft and decayed wood in the frame area . Decay in the door frames can result in leaking and water penetration and should be repaired as soon as possible. A general repair specialist or licensed general contractor should be consulted for evaluation and repair.

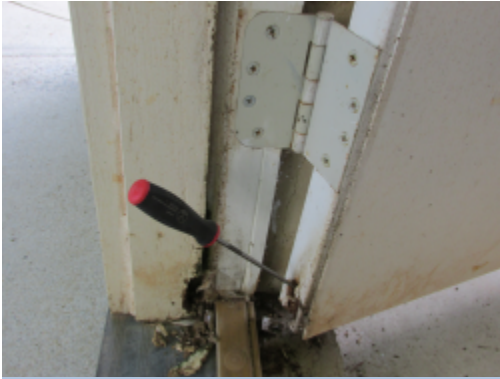
(B2 - 2.2) Door

Additional Photograph: The door also has soft and decayed wood in the door panel area. Decay in the door panel can result in leaking and water penetration and should be repaired as soon as possible. A general repair specialist or licensed general contractor should be consulted for evaluation and repair.

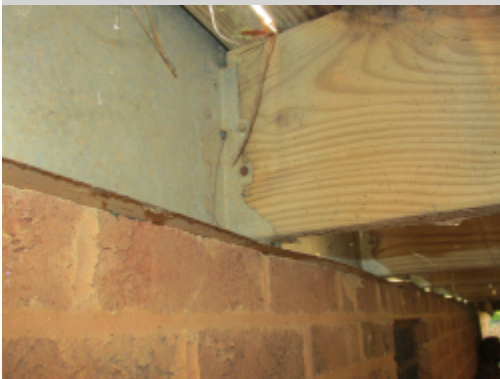
(B3 - 1.1) Deck Sample 1

The metal hangers used to support the floor framing of the deck were installed without the proper number and sized nails. The nail installation is crucial to the function of the hanger, without proper installation the hanger could fail allowing the deck to move or collapse. A licensed general contractor should be consulted for complete evaluation of the deck and to make necessary repairs.

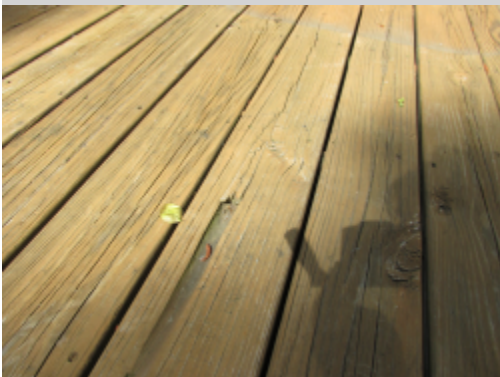
(B3 - 1.2) Deck Sample 1

The wood deck was found to be severely weathered. Decking boards were splintering and cupped. The deck should be considered hazardous. A licensed general contractor should be consulted for complete evaluation of the deck and to make necessary repairs.

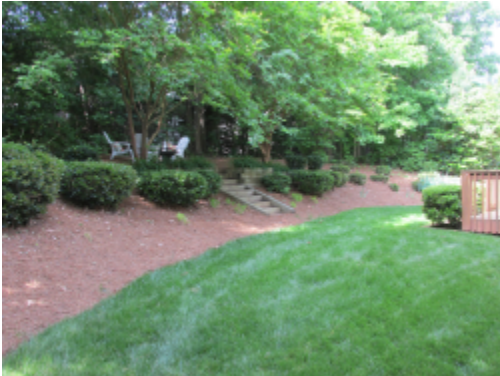
(B5 - 1.1) Grading

The rear yard slopes toward the home and there is evidence of erosion of soil along the sides yards that is directing drainage against the perimeter of the home. Corrections are needed to control drainage and prevent water penetration, a licensed general contractor should be consulted for a complete evaluation and to make necessary repairs.

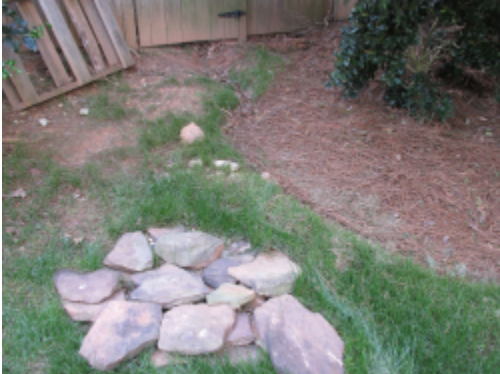
(B5 - 1.2) Grading

Additional Photograph: Evidence suggests that the drainage from the rear section of the lot accumulates along the fence and left foundation wall.

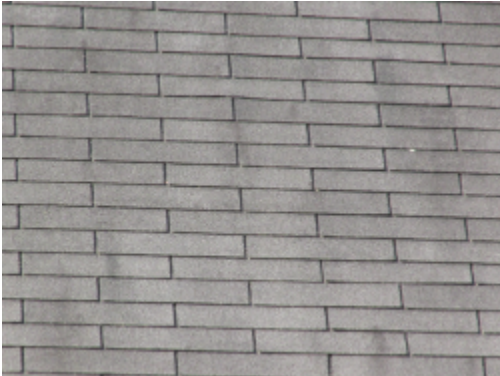
(C1 - 1.1) All Accessible Areas

The roof shingles were noted to be lifting or curling at the corners of the tabs. Since shingles are designed to lay flat to shed water and debris, the curling can result in trapped moisture and leaks. Shingle curl for several reasons including: end of the service life, improper installation and or limited ventilation. A licensed roofing contractor should be consulted for a complete evaluation of the roof covering and flashings system to make necessary repairs to ensure the weathertightness of the roof covering system. At the time of the repair, the roofer may be able to answer questions related to the life expectancy of the roof covering system.

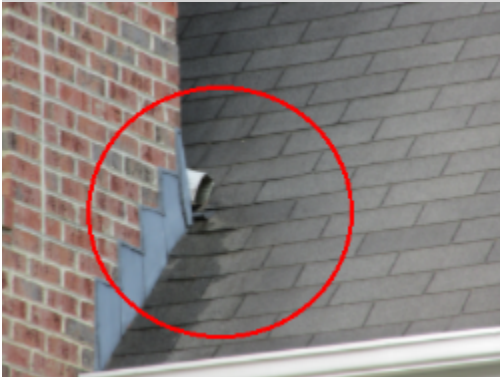
(C2 - 1.1) All Accessible Areas

The gutter downspout at the right dormer is not extended or piped out to direct roof drainage away from the side wall of the main home. Direct drainage from the gutter system can result in direct water penetration into the attic areas of the home. A licensed general contractor should be consulted for a complete evaluation and to make necessary repairs.

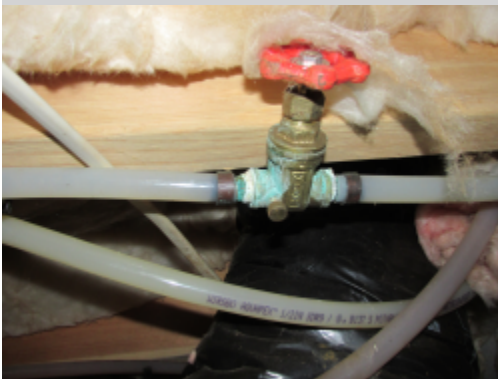
(D1 - 1.1) All Accessible Areas

The main water supply line located in the crawl space at the back door is corroded. Corrosion on the main water lines should be addressed as soon as possible to prevent major leaks and property damage. A licensed plumbing contractor should be consulted for a complete evaluation and repair of the main water supply line.

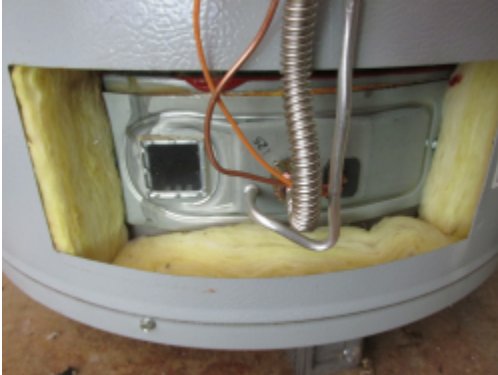
(D3 - 1.1) Unit #1

There was no hot water available for the main home during the inspection. The gas service to the unit was off. The inspector did not have permission or knowledge of the circumstances that required the unit to be turned off and therefore did not turn the unit on. The inspection of the hot water heating unit, fixtures, and appliances was limited and not completed. It is recommended that the hot water be restored and the inspection completed prior to the purchase of the home.

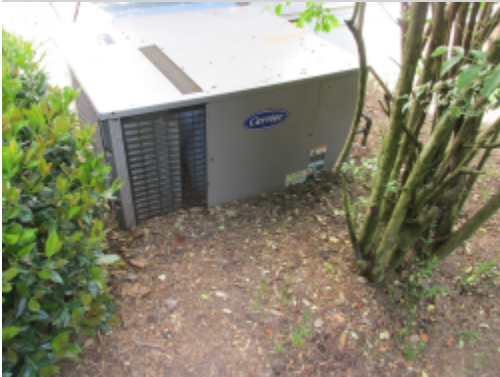
(F1 - 1.1) Heating Unit #1

The grading around the package HVAC unit is directing drainage toward the unit. Evidence suggests that water from lot drainage has been entering the unit., see next photograph. Drainage needs to be corrected to prevent damage to the unit. A licensed general contractor should be consulted for further evaluation and repair.

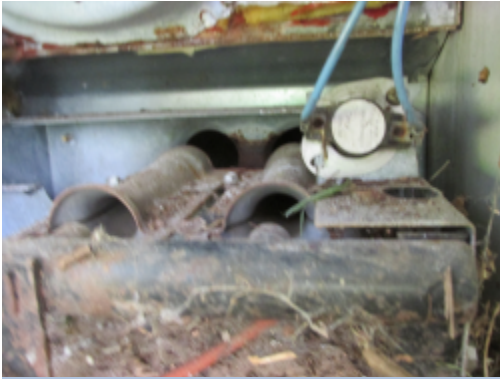
(F1 - 1.2) Heating Unit #1

The gas burner section of the package unit has visible rust and debris in the burner chamber area. The rust indicates deterioration of the exchanger. Deterioration of the heat exchanger is a serious concern that can result in improper combustion and carbon monoxide poisoning. The furnace needs a complete evaluation which should include a heat exchanger inspection to ensure safe, reliable, and proper operation of the HVAC system. A licensed HVAC contractor should be consulted for repair.

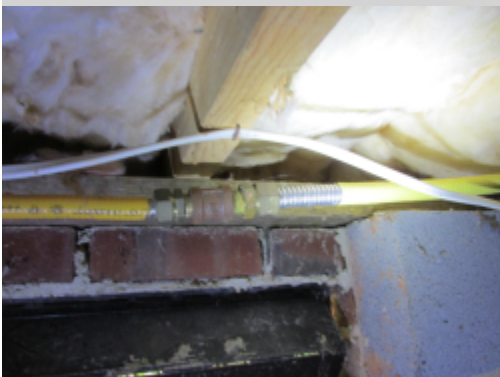
(F3 - 1.1) Crawl Space

This home has corrugated stainless steel gas lines. This gas line has specific installation requirements related to required bending allowances, support, protection, and electrical bonding to ensure safe conditions. The electrical bonding is typically required to prevent damage from electrical storms in the event of a lightning strike. During the home inspection the bonding attachment could not be located. An electrical contractor should be consulted for a complete evaluation of the CSST installation and to verify the presence of electrical bonding.

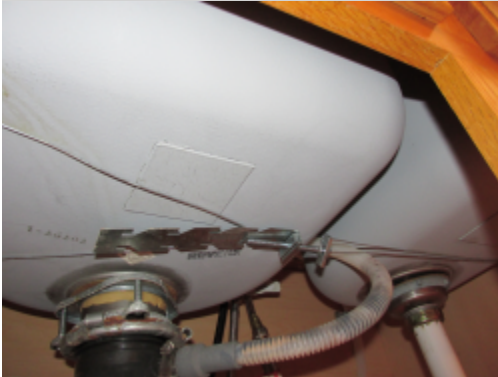
(H2 - 1.1) Kitchen

The sink is in need of further evaluation and repair. The following concerns were noted at the time of the inspection:

1. The sink is supported by a wire and bracket was not secure. A general repair specialist or licensed general contractor should be consulted for evaluation and repair.

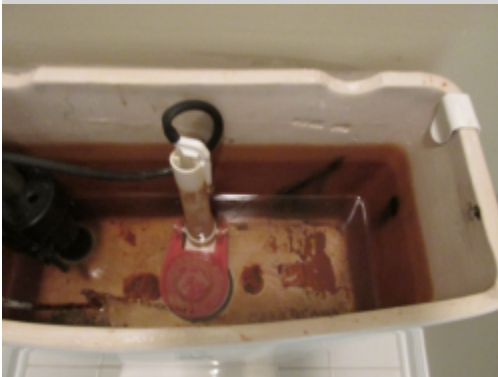
(H3 - 1.1) Bathroom #1 Master

The toilet flush valve is not operating properly. This could result in improper functioning, flooding and waste of water. A licensed plumbing contractor should be consulted for evaluation and repair.

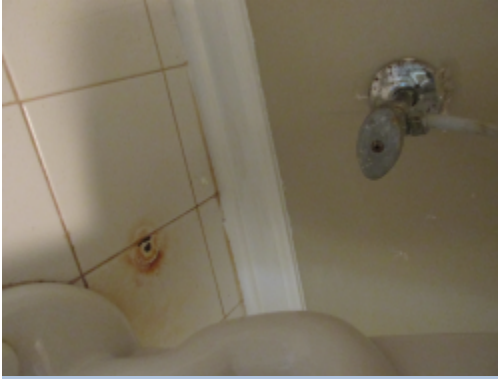
(H3 - 2.1) Bathroom #2

The floor area under the toilet tank has a rust stain indicating a history of a leak or a seeping leak at the tank bolts or water turn off. The toilet tank bolts/gaskets and the turn off valve need to be evaluated by a plumber to ensure that they are not leaking. A licensed plumbing contractor should be consulted for evaluation and repair.

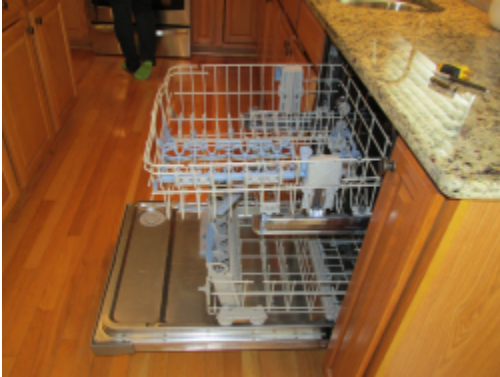
(J1 - 1.1) Dishwasher

The dishwasher is not secure to the cabinet and it moves forward when the door is opened. The appliance needs to be secured to the cabinet to prevent damage to the unit or personal injury. An appliance repair person or general contractor should be consulted for repair.
